Aura Apartments: A Case Study for Reviewing the BCC Response to the Brisbane Flood Event

36 Units in Ferry Road, West End near Riverside Park

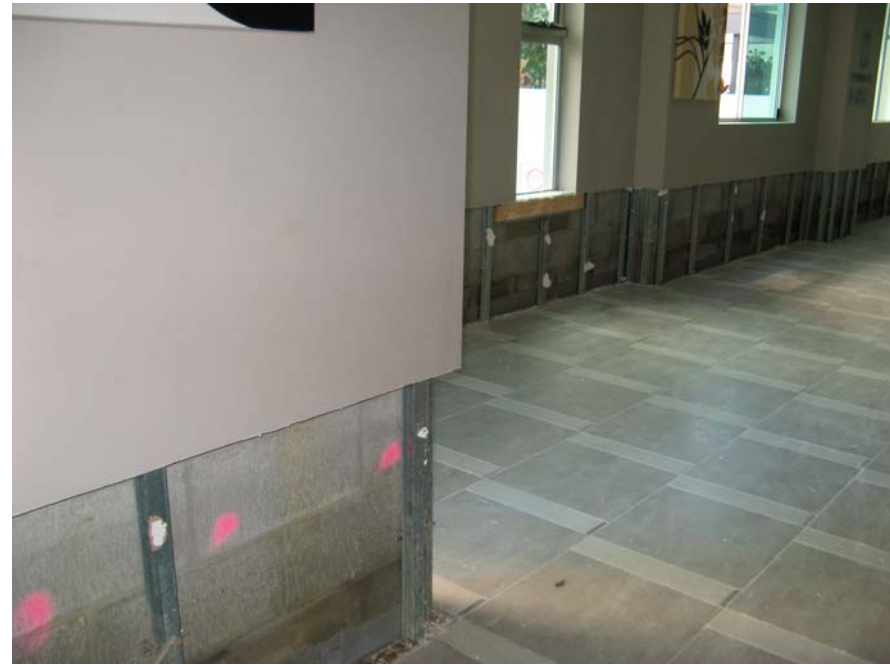
Aura Apartments were flooded in the January 2011 Brisbane floods up to approximately 0.5 metres above the ground floor level at RL5.9, badly damaging the building, furniture and contents of the common rooms, swimming pool, and four ground floor apartments.

Damaged walls in the Aura foyer

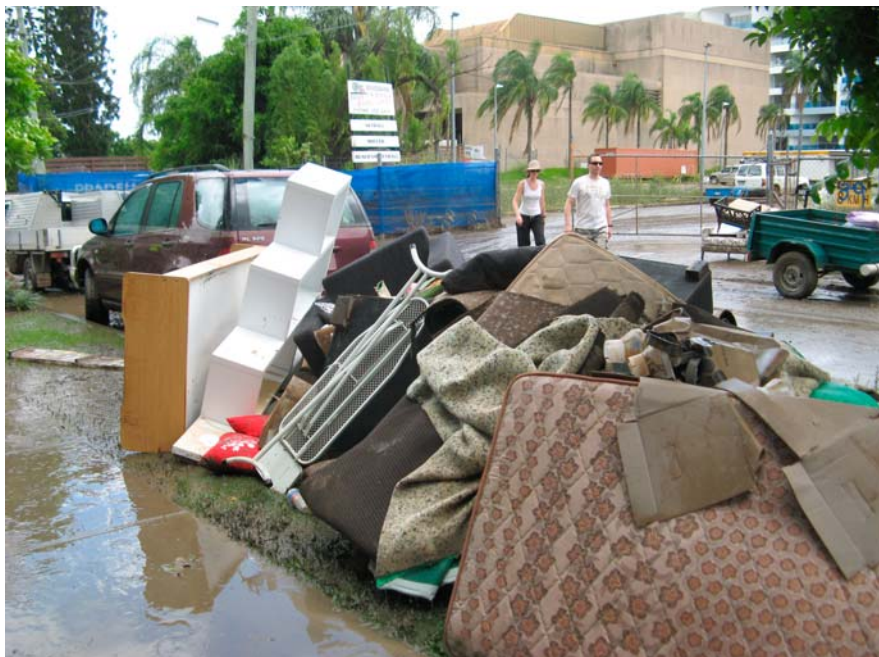
Pile of damaged contents from Aura

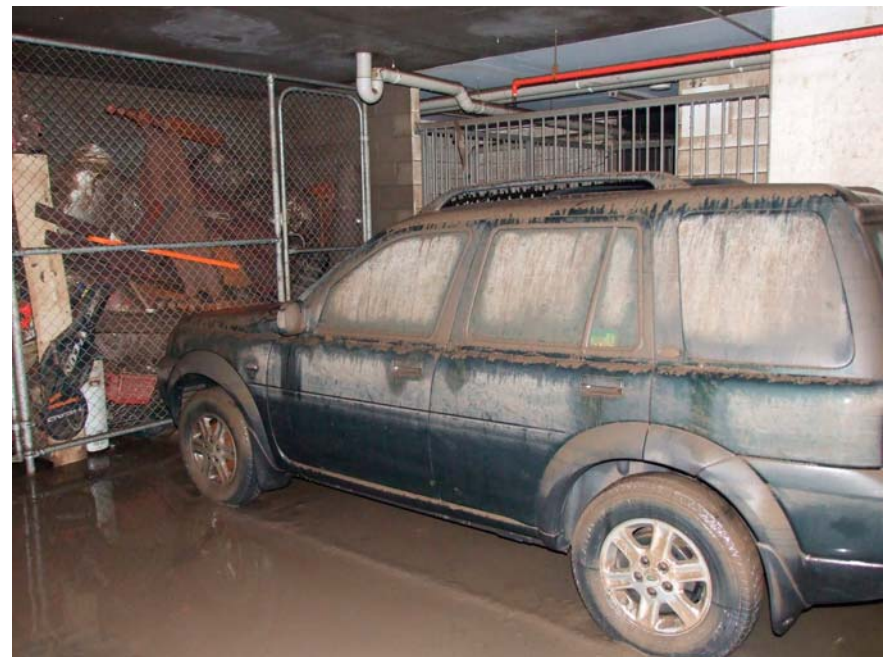
Car and contents submerged in Aura basement

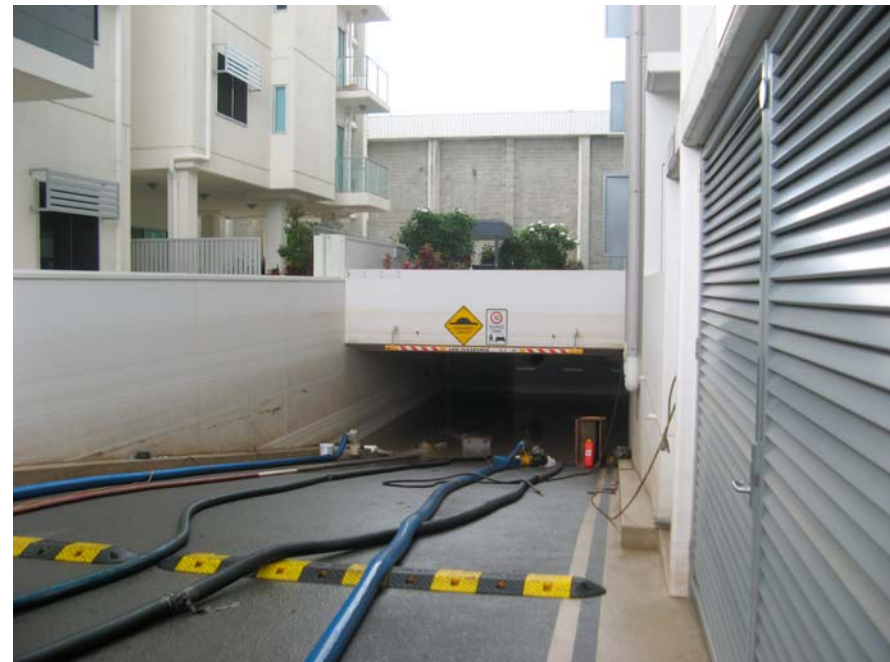
- The ground floor was built at RL5.9, a level approved under the existing regulations. This was inadequate for Aura as water rose up to around 6.4 metres in our building and street in the January 2011 floods. This implies a design Q100 flood level of RL5.4. This level was far too low in Riverside South, West End and may even have been below the 1974 flood.
- A Q100 standard is not appropriate in this area if it relates to a level of rainfall intensity occurring in the local area rather than a riverine flood caused by intense rainfall in the upper Brisbane valley.

Carpark entrance with a mud line showing the height of the water

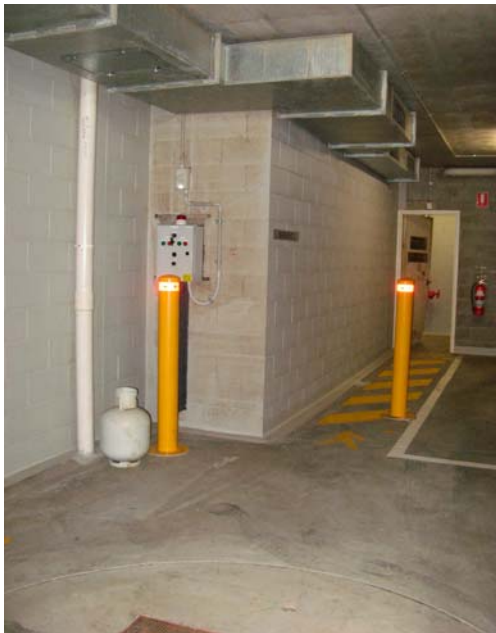
- The building has two basement car parks. It took 1 day to remove water from the first carpark, but another 7 days to empty the second carpark. Regulations need to stipulate building designs with access holes that make it easier to pump water out of second basements.
- The building's normal de-watering system consists of a sump below the floor of Basement 2 with electric sump pumps under automatic level control. The power controls to the sump pumps are on the wall in Basement 2. Any basement de-watering fails when power is lost or when the control panel is flooded. Council should require such control panels to be above the design flood level and require buildings to have backup power in case of power outages.

De-watering pump controls in Basement 2

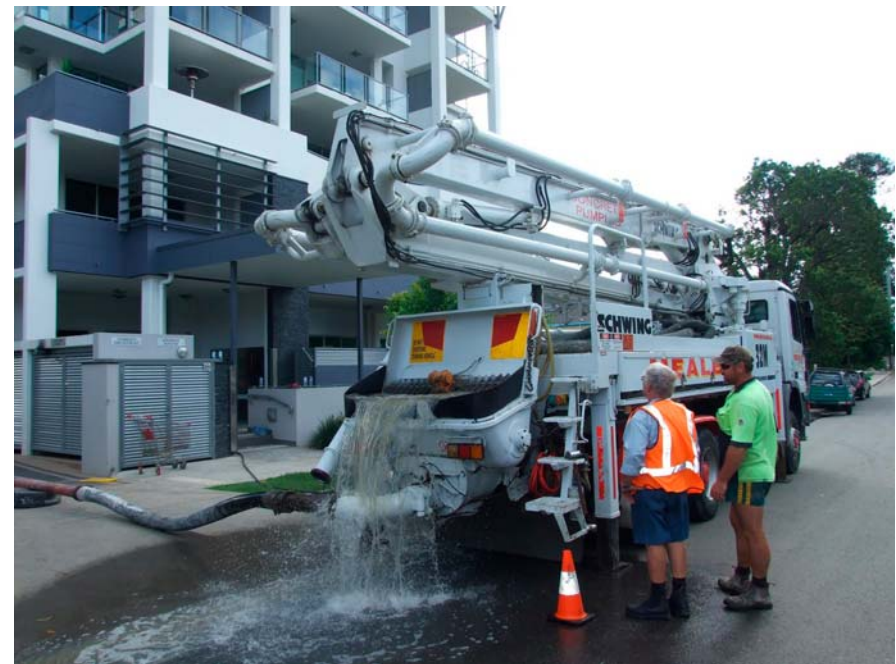
Pump truck needed to pump out Basement 2

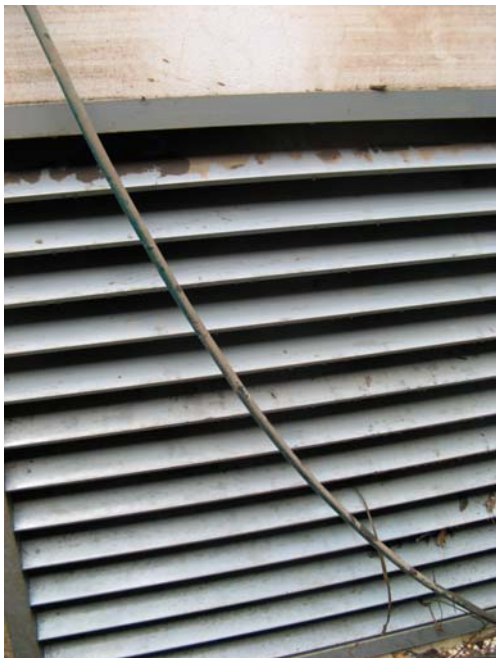
- The Council approved building plans for grills for ventilation into the B1 carpark. These grills are well below the ground floor level of the building, and below the design Q100 flood level.

Close up of vents where water spilled into the B1 carpark basement

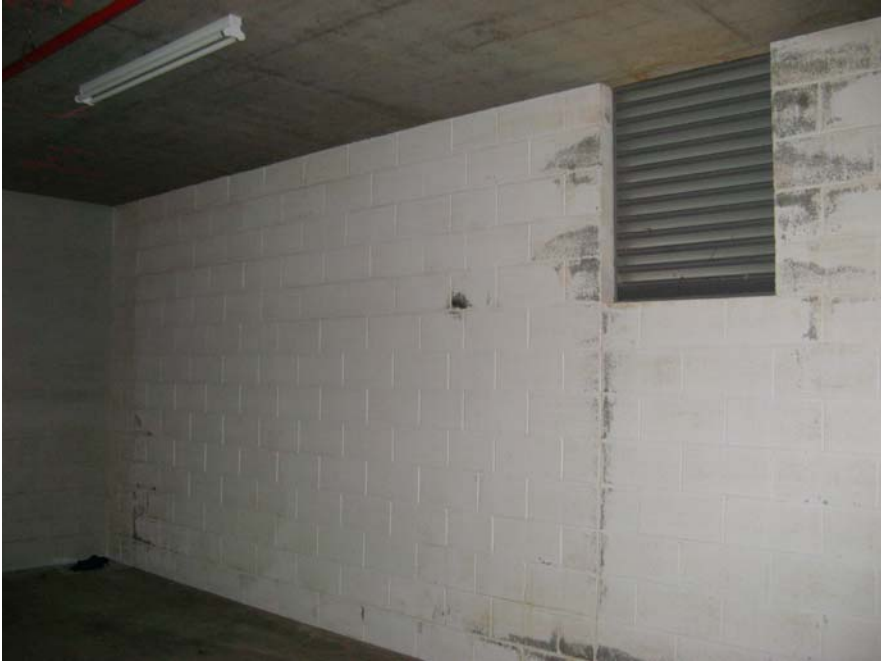
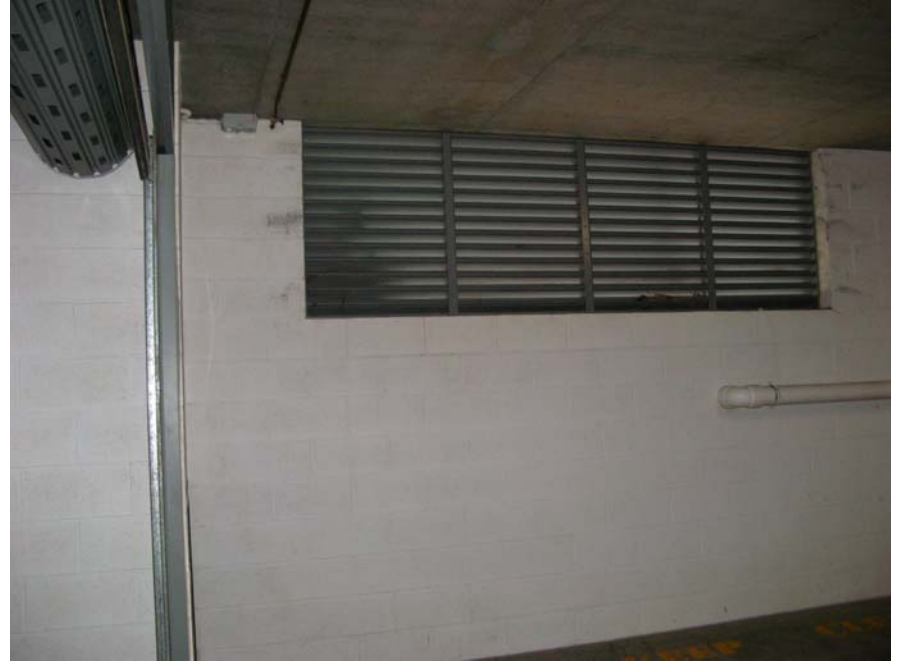
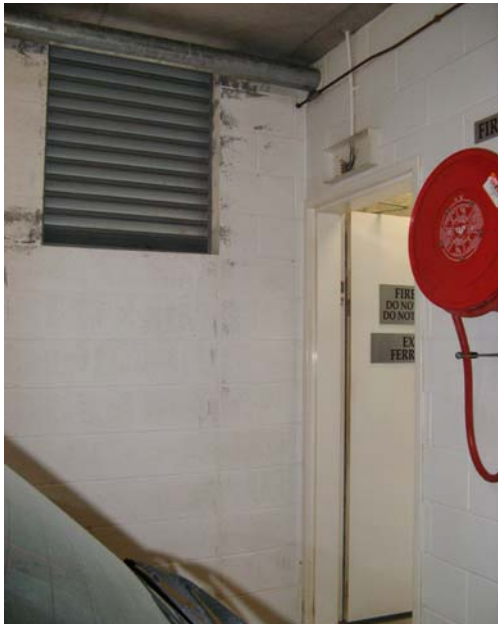
Basement 1 vents where water entered carpark

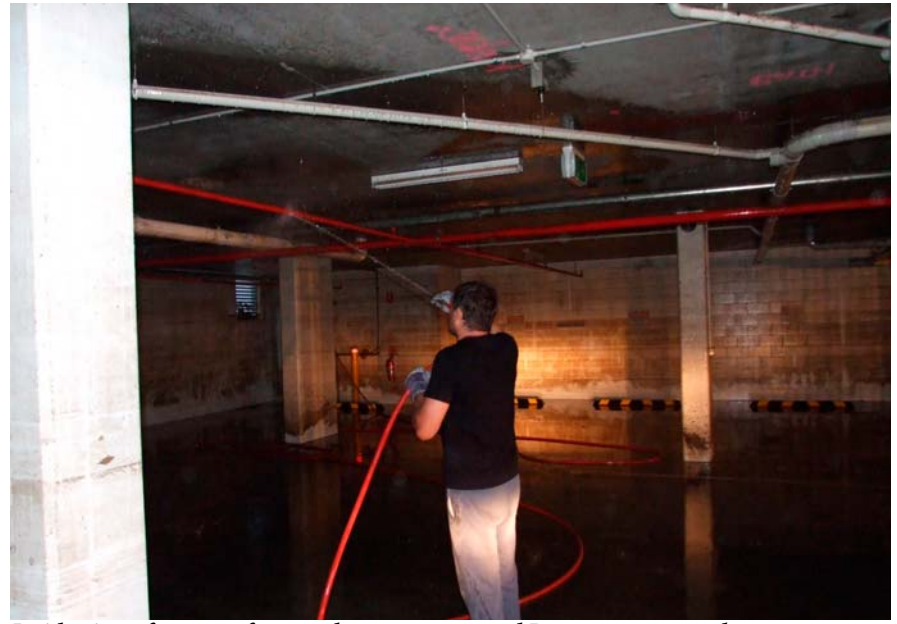
Inside view of one set of vents where water entered Basement 1 carpark

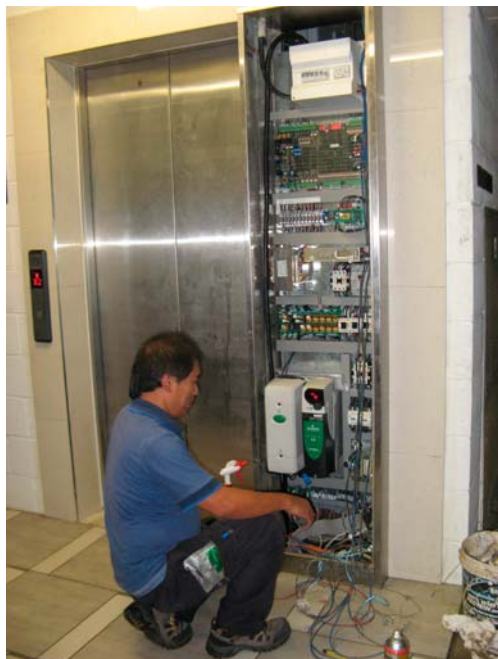
- The lift motors and controls are located in the Basement 2, so they were badly affected by flood water and they are very expensive to replace, costing over \$40,000. In Aura there is room for the lift to be placed at the top of the lift shaft, but relocating the motor and controls is very expensive at over \$250,000. Council regulations requiring lift motors and controls to be put above flood water levels would have saved residents in Aura many thousands of dollars.

Aura lift control panel beside the lift in Basement 2 positioned at the lowest point in the building

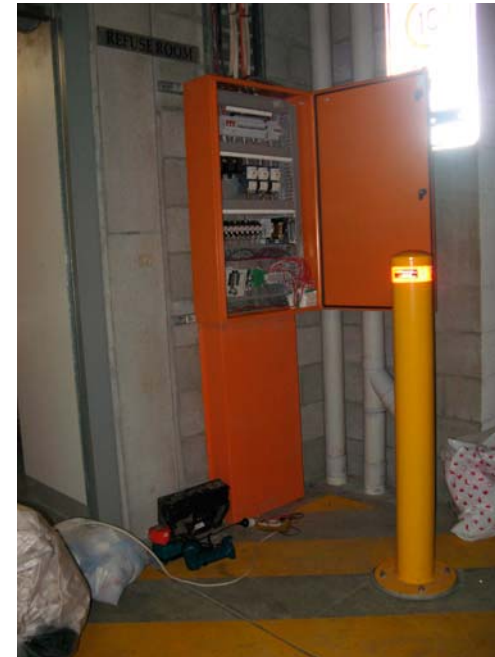
- The control panel for the CO₂ ventilation system is located in Basement 1, so this was another expensive service to replace. Repairs will cost over \$20,000. Not all parts of this system can be relocated, but the control panel could be. However, retrofitting this panel is expensive. The Council could require developers of buildings in flood-prone areas to put the control panel above flood levels.

CO₂ Panel controls in Basement 1 beside the lift shaft

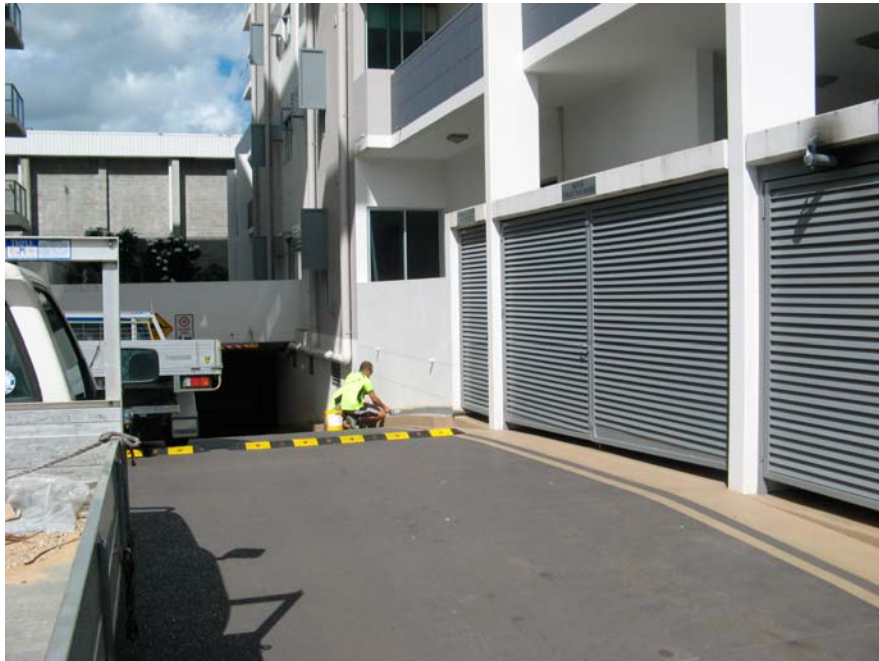
- The Council approved the location of fire services below the RL5.9 level required for the ground floor. That resulted in the sprinkler system, the pumps and control board being badly affected by the flood waters and these will cost over \$27,000 to replace.

Two rooms either side of refuse room below ground floor beside the carpark entrance housing the fire sprinkler pump (left), the main fire pump and controls (right)

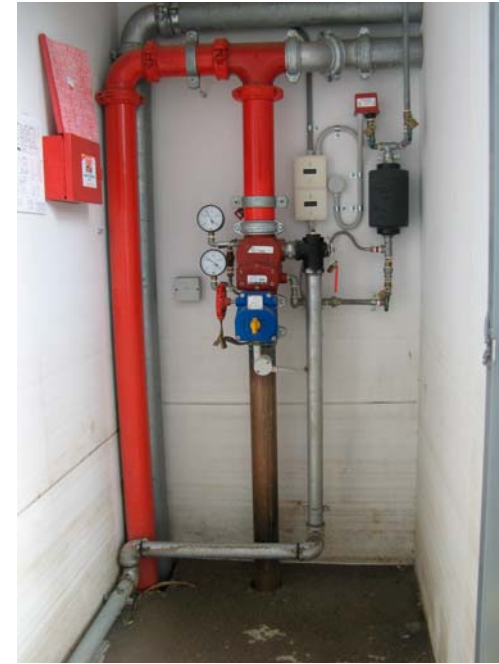
Inside the fire sprinkler system that was damaged by water

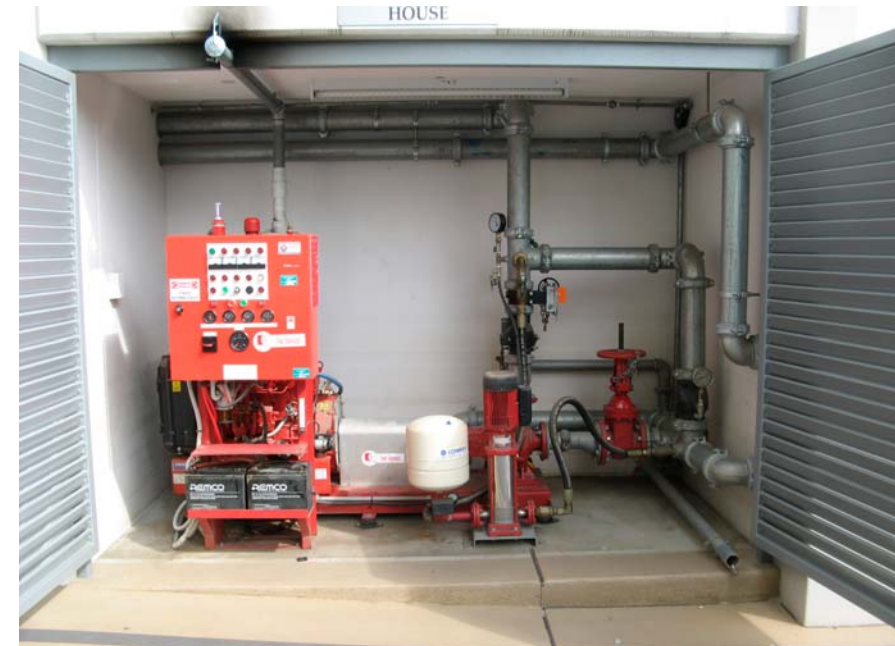
Main fire sprinkler and pump damaged by water

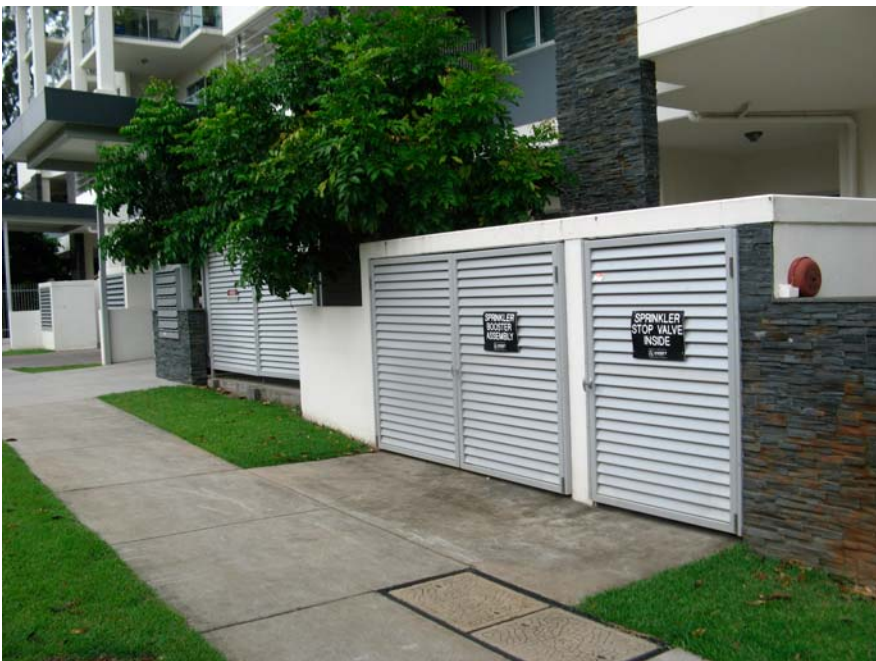
- The Energex transformers for the Aura and Arriva Apartments located in front of Aura's sister building next door sit at the ground floor level, so it was affected by water inundation and had to be turned off when flood waters began rising. That meant that the pumps in the basements stopped working and residents could no longer live in the buildings, even if they were not directly affected by water. The regulations need to stipulate that vital services, such as energy supplies, should be well above any flood levels.

Room on left under tree housing Energex transformer for Arriva & Aura Apartments where water entered

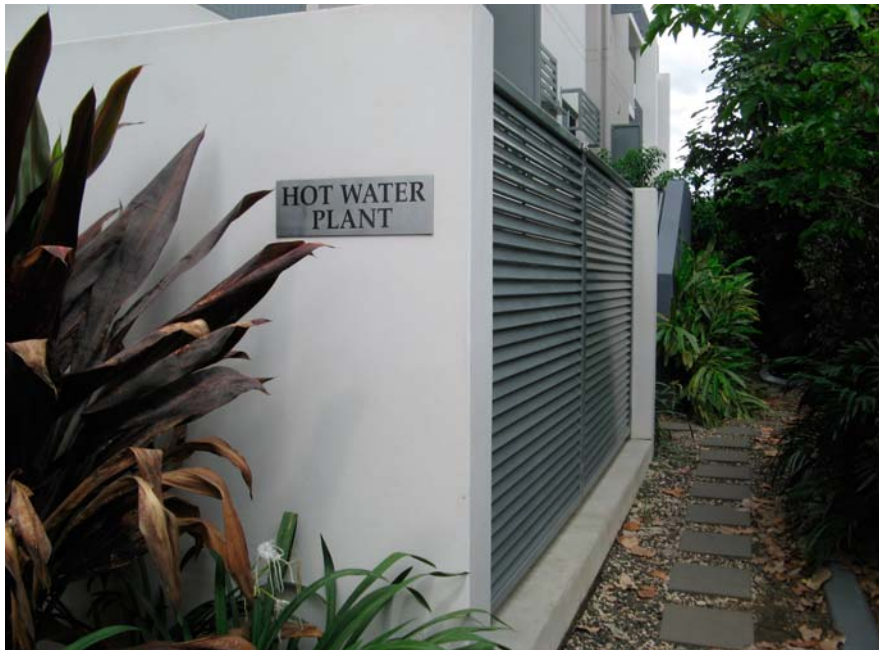
- The gas-fired water heaters and electric pumps were completely submerged and needed to be replaced. Residents did not have hot water for some time and then a limited service until units could be replaced. Located in the sunken garden, these heaters are well below the ground floor level of RL5.9.

Room housing the water heaters beside the building and well below the building ground floor

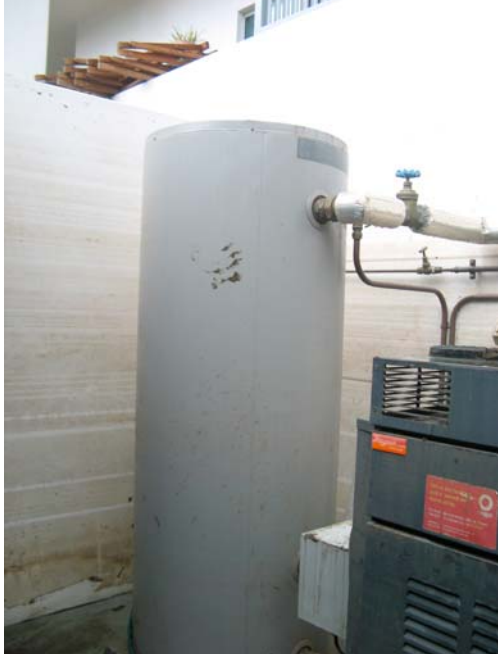
Water heaters that were completely submerged and damaged beyond repair

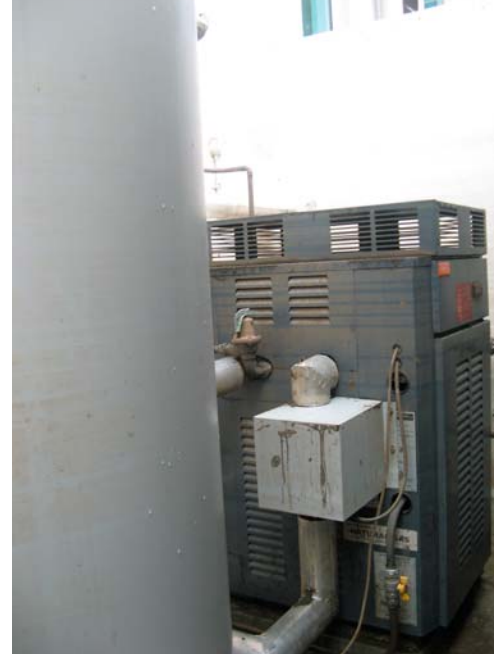
Water heater controls that were completely submerged and damaged by water

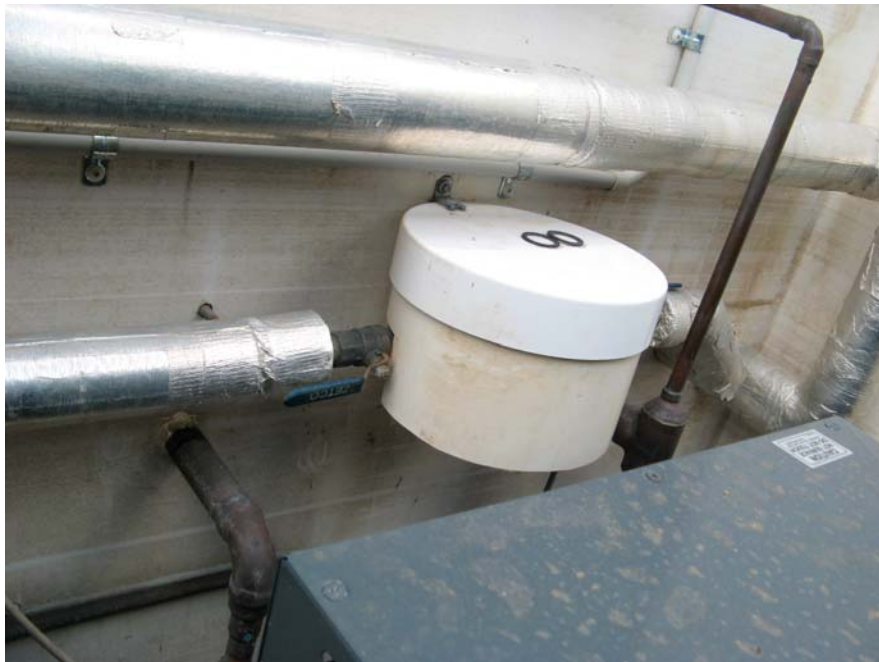
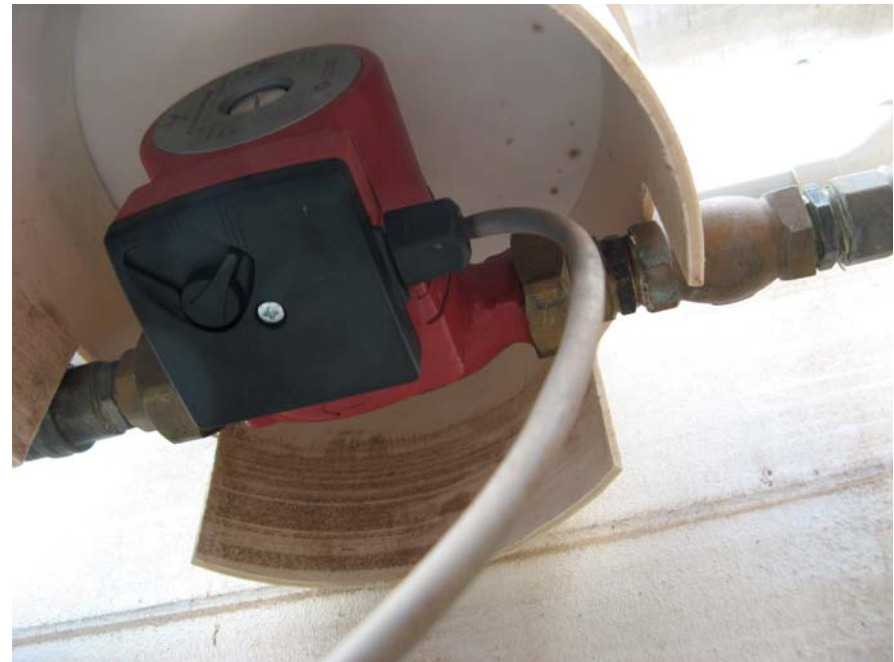
Hot water recirculation pump that cost Aura \$450 to replace

Close up of hot water recirculation pump that needed to be replaced

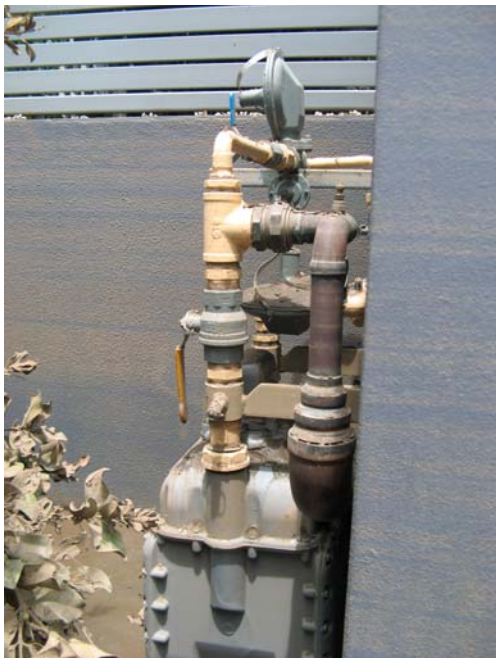
- The gas valves in Aura are located in the sunken garden below ground floor level and were completely submerged by water.

Main gas valve

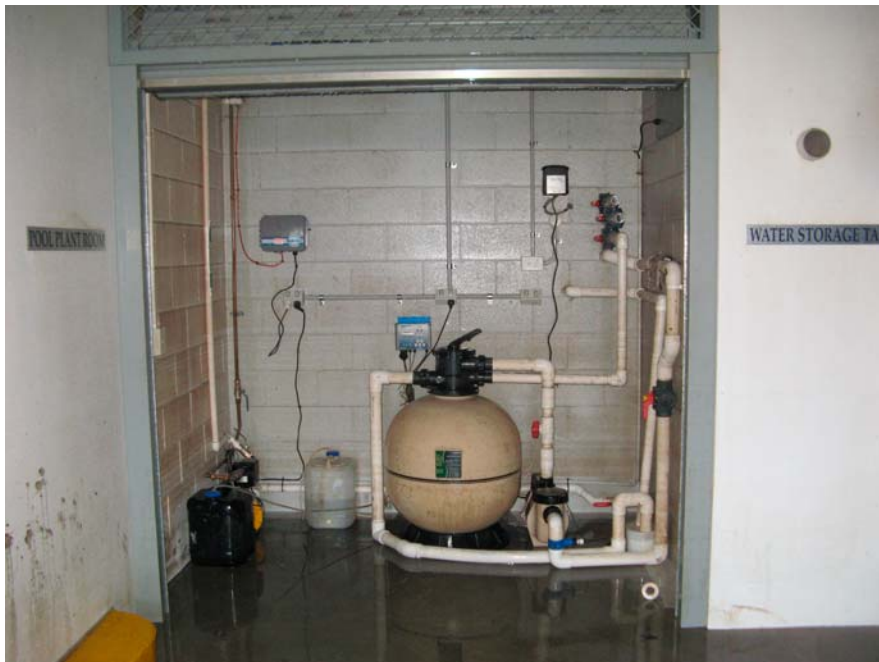
- The Aura pool was inundated by flood waters, but the pool pumps and controls located under the pool in the B1 carpark were also damaged and repairs will cost around \$3000.

Close up of damaged pool controls in room with door raised on Basement 1

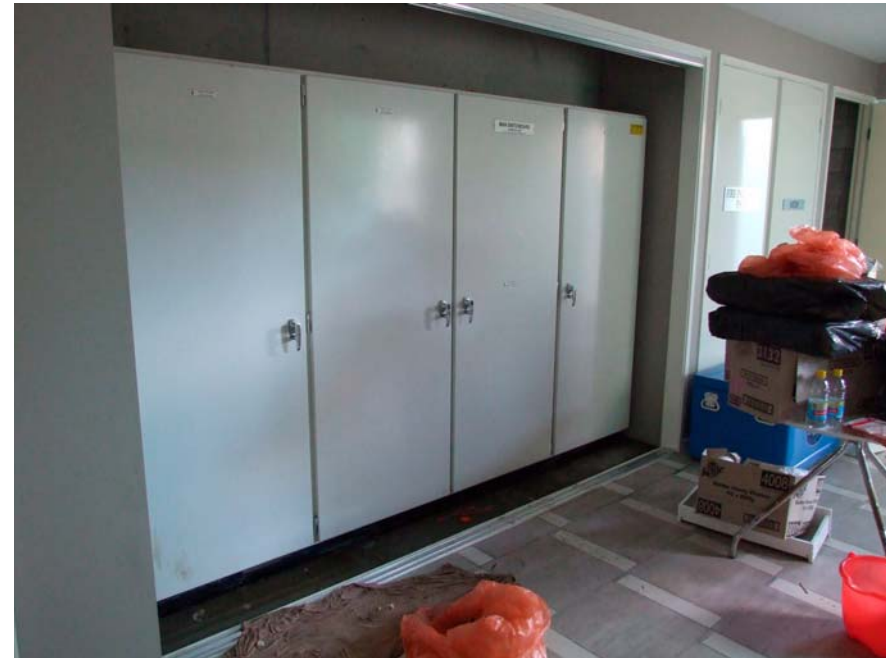
- The power, fire alarm, video and telephone cabling control panels in Aura are on the ground floor so they were partially affected by water, unlike other multi-storey buildings in the West End, which had more major damage because their control panels were located in basements. The Council should require all buildings to have these control panels above any flood levels.

Power control panel inside Aura's foyer where partial damage occurred to the building power distribution.

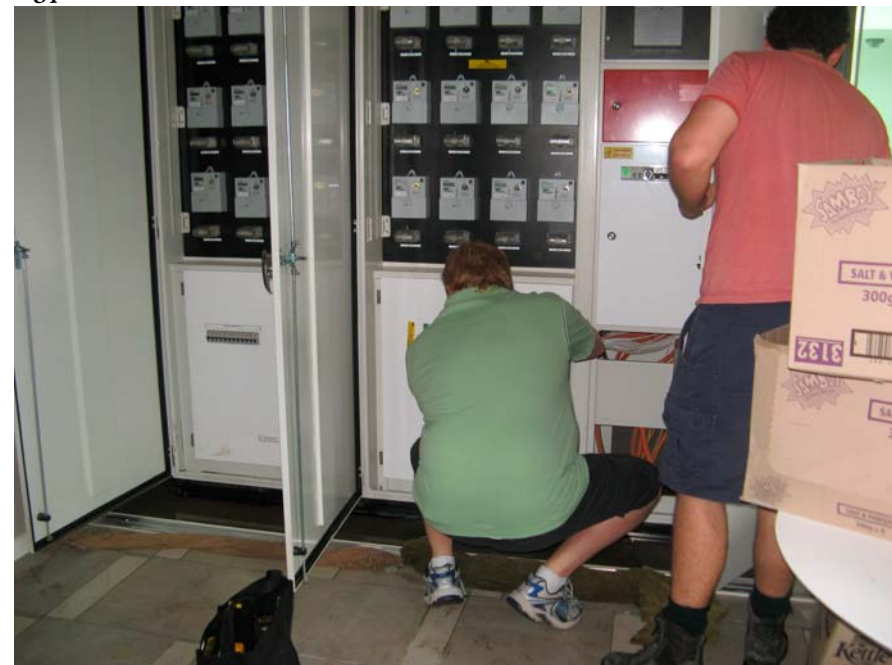
The main isolator switch on the power board was located at the lowest point on the panel and was the most expensive power component to replace

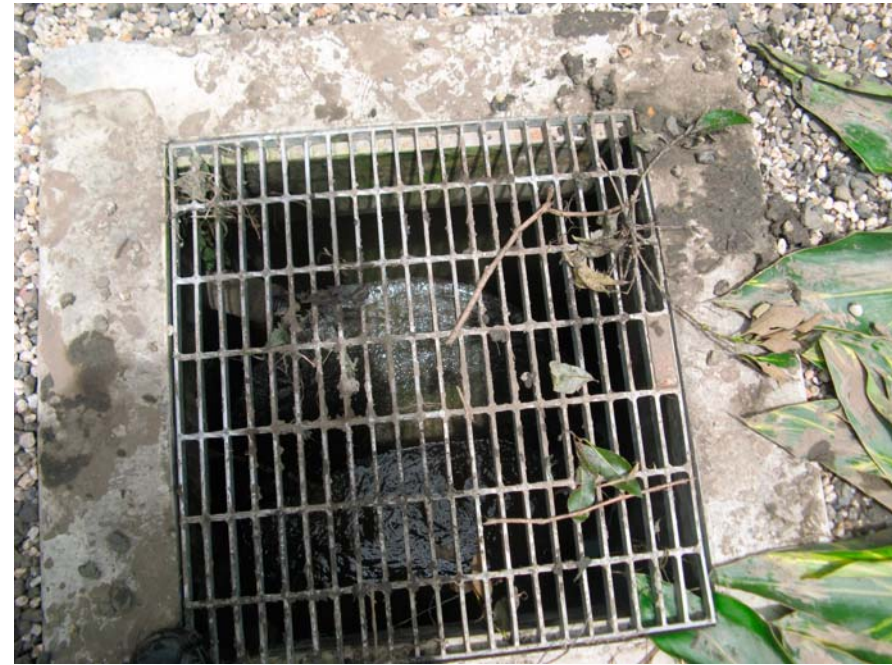
- The stormwater drain around Aura could not cope with the volume of water and the first inundation occurred from stormwater, which bubbled up through the drain with such force it lifted one of the grates. One resident then fell down into the open hole, which was under water. The Council needs to better design for stormwater runoff in West End.
- This stormwater grate is located on the main emergency exit pathway from the fire stairs. The pathway was flooded to knee level at the time the building was evacuated. This is an unsafe design that should not be allowed by the building code.

The large grate giving access to the stormwater drain at the side near the footpath gate on 14/01/11 at 1.04 pm, which can drown a person, if they fell in and could not get out

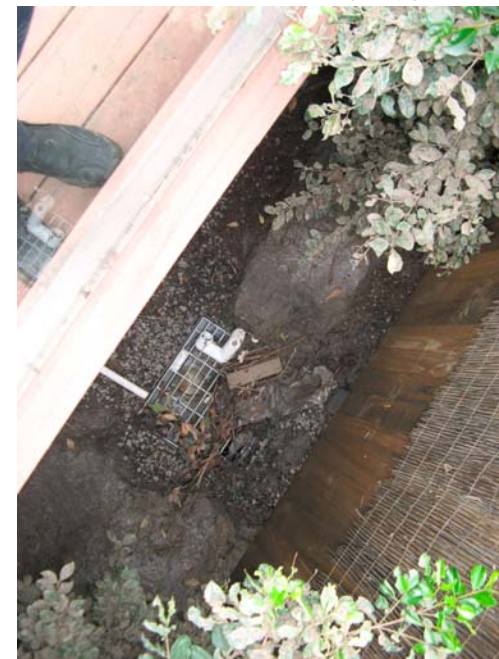
Aura stormwater drain on 14/01/11 at 2.53 pm showing where water bubbling up has not allowed any mud to settle around the grate

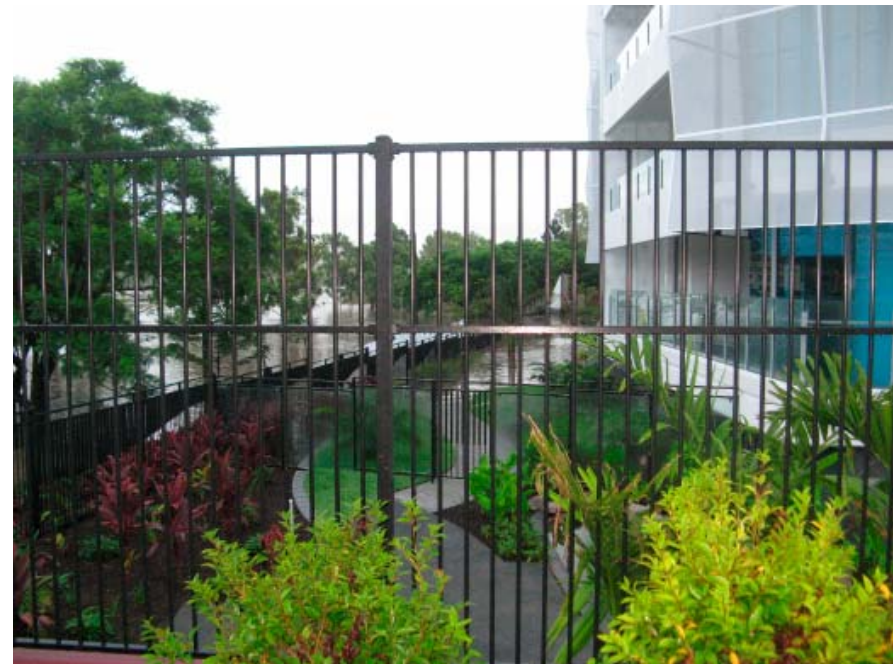
- River water flowed over the bank in places along Riverside Drive and entered buildings and, possibly affected Aura. Instead of requiring developers building beside Riverside Drive to raise the bank, Council allowed the developers of Waters Edge to lower the bank and this was one of the places where river water flowed inland.
- The Council is not fully using substantial funds paid by developers in West End to Council to ensure the main stormwater drainage system is capable of controlling run off.

View of water entering Waters Edge on 12/01/11 at 5.08 am
