Aura Apartments: A Case Study for Reviewing the BCC Response to the Brisbane Flood Event

36 Units in Ferry Road, West End near Riverside Park

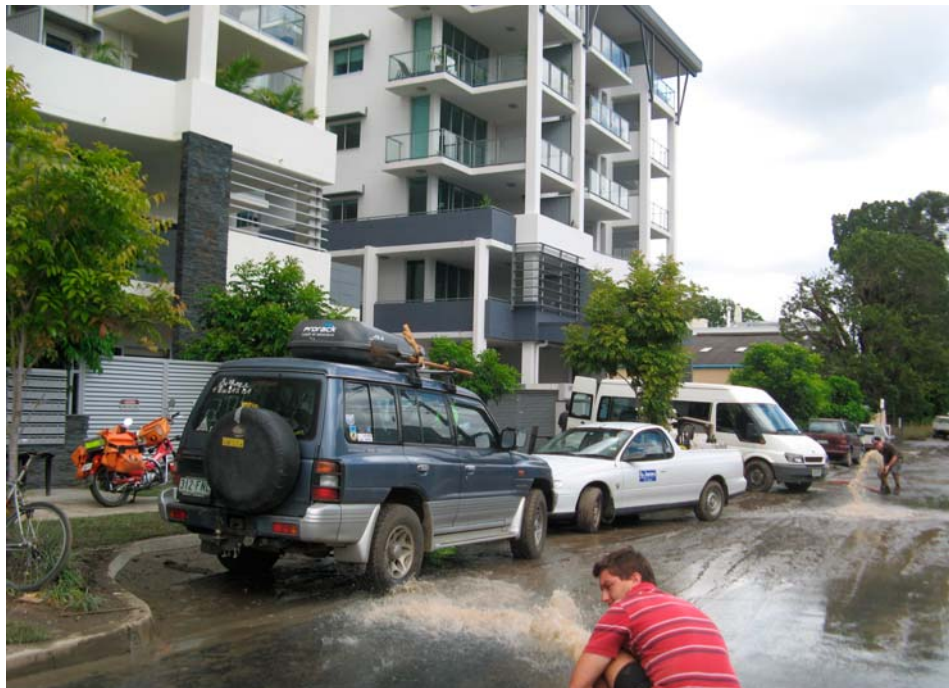
Cleaning the mud outside Aura Apartments on 14/01/11 at 12.04 pm

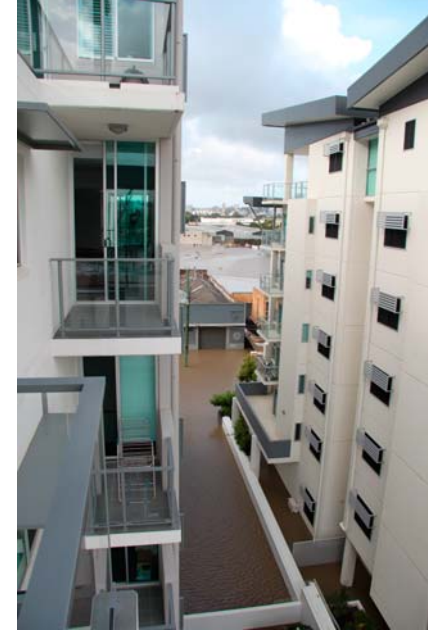
- The ground floor was built at RL5.9, a level approved under the existing regulations. This was inadequate for Aura as water rose up to around 6.4 metres in our building and street in the January 2011 floods. This implies a design Q100 flood level of RL5.4. This level was far too low in Riverside South, West End and may even have been below the 1974 flood.
- A Q100 standard is not appropriate in this area if it relates to a level of rainfall intensity occurring in the local area rather than a riverine flood caused by intense rainfall in the upper Brisbane valley.

Taken from Unit 32 at Aura on 12/01/11 at 5.13 pm looking towards the city

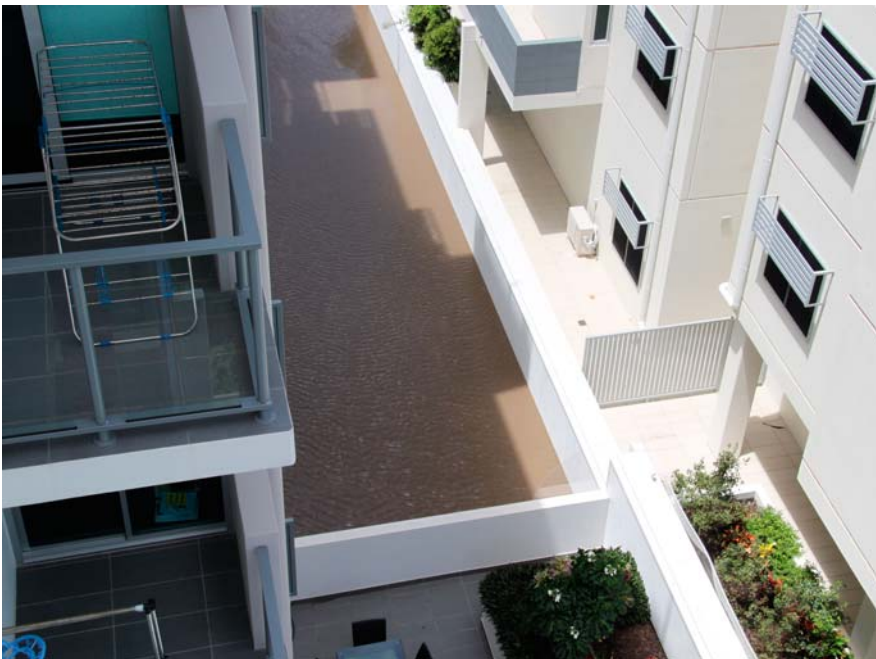
View of the carpark entrance with water still rising at 1.19 pm on 12/01/11

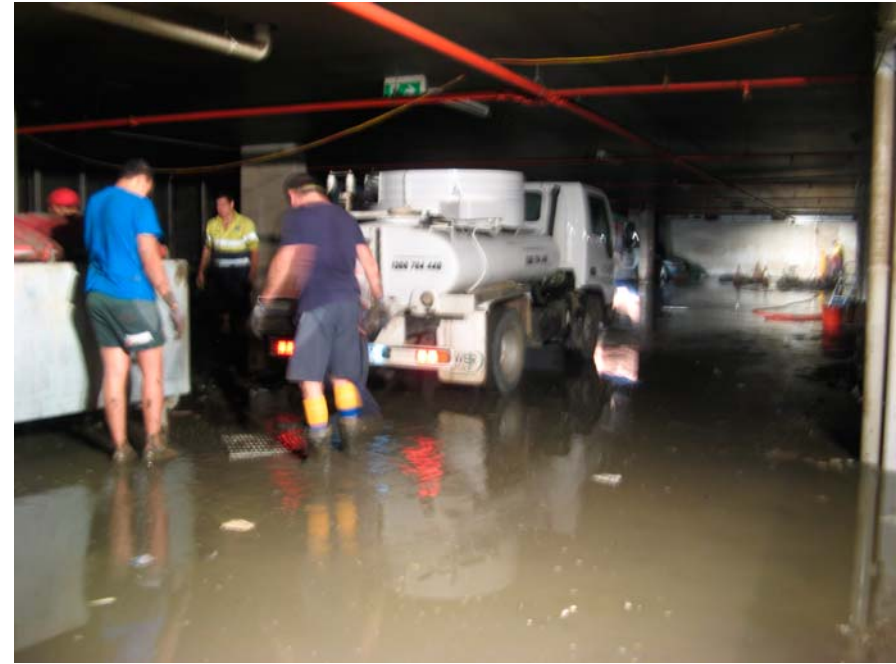
- The building has two basement car parks. It took 1 day to remove water from the first carpark, but another 7 days to empty the second carpark. Regulations need to stipulate building designs with access holes that make it easier to pump water out of second basements.
- The building's normal de-watering system consists of a sump below the floor of Basement 2 with electric sump pumps under automatic level control. The power controls to the sump pumps are on the wall in Basement 2. Any basement de-watering fails when power is lost or when the control panel is flooded. Council should require such control panels to be above the design flood level and require buildings to have backup power in case of power outages.

Pumping out the mud from the sump pumps on 29/01/11

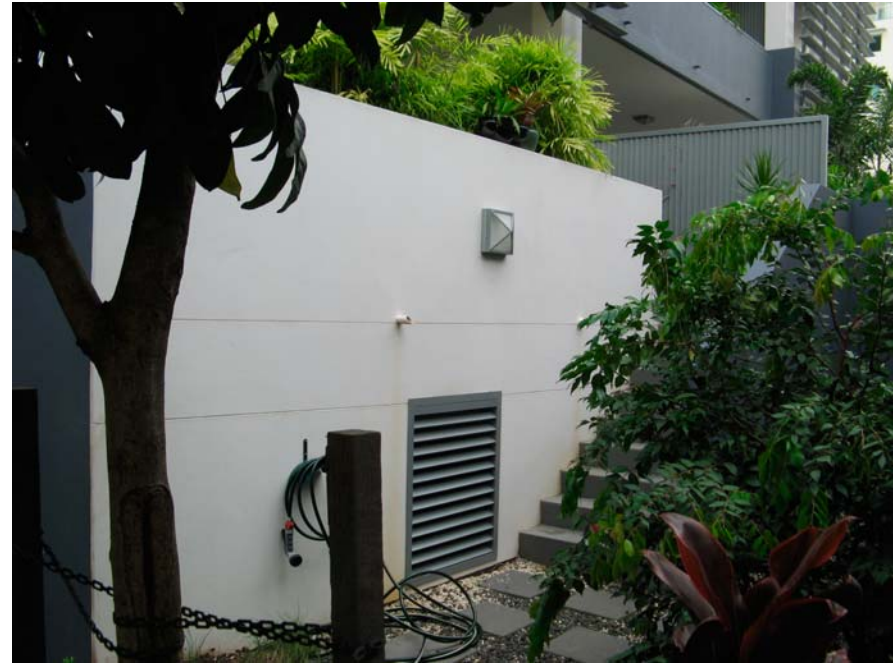
- The Council approved building plans for grills for ventilation into the B1 carpark. These grills are well below the ground floor level of the building, and below the design Q100 flood level.

Vents at the back of Aura with the sunken garden below ground level

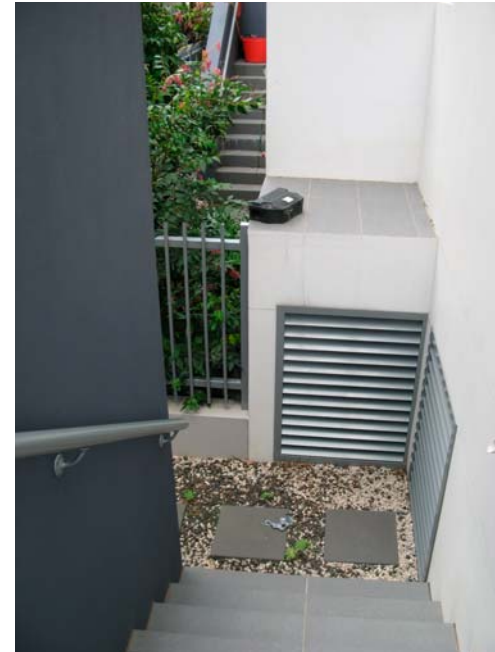
Stairs from ground floor leading to back garden with vents where water spilled into B1 carpark

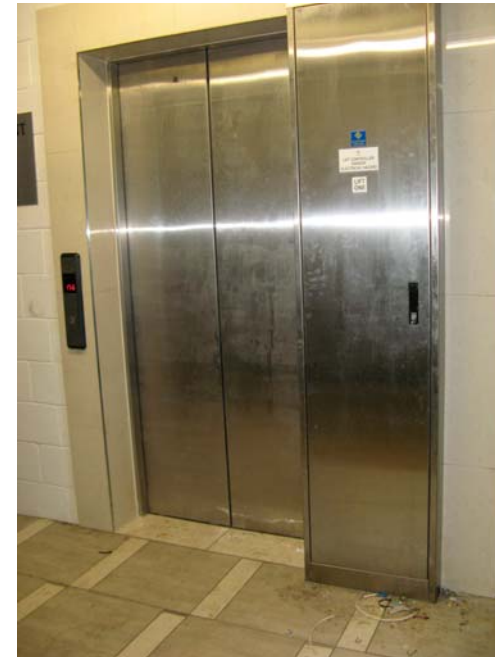
- The lift motors and controls are located in the Basement 2, so they were badly affected by flood water and they are very expensive to replace, costing over \$40,000. In Aura there is room for the lift to be placed at the top of the lift shaft, but relocating the motor and controls is very expensive at over \$250,000. Council regulations requiring lift motors and controls to be put above flood water levels would have saved residents in Aura many thousands of dollars.

Aura lift doors on Basement 2 with controls on the right

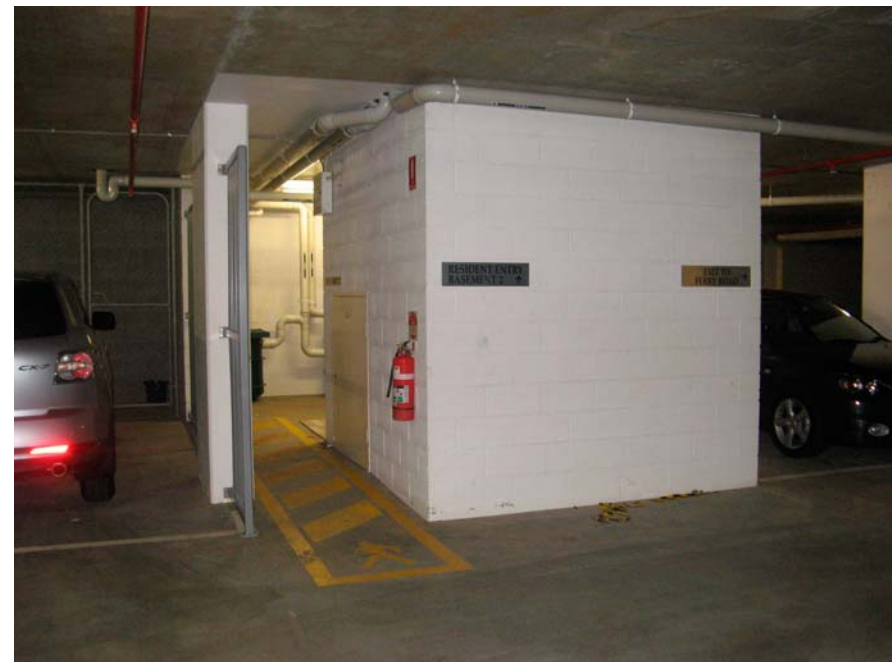
Lift well in Aura in Basement 2 with the main lift motor behind the yellow door in the wall near the fire extinguisher

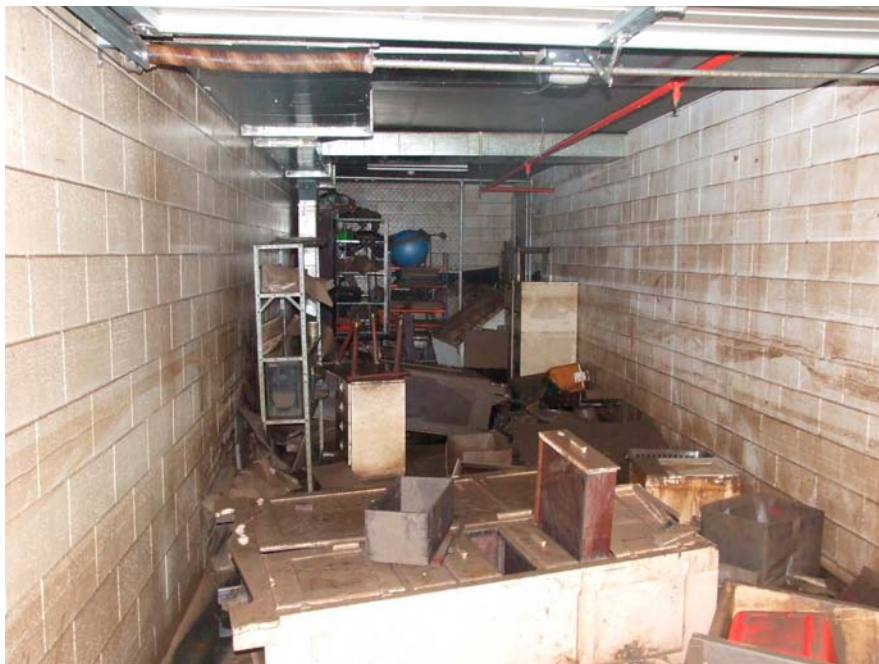
- The control panel for the CO₂ ventilation system is located in Basement 1, so this was another expensive service to replace. Repairs will cost over \$20,000. Not all parts of this system can be relocated, but the control panel could be. However, retrofitting this panel is expensive. The Council could require developers of buildings in flood-prone areas to put the control panel above flood levels.

Metal ducts in the roof are part of the CO₂ control system

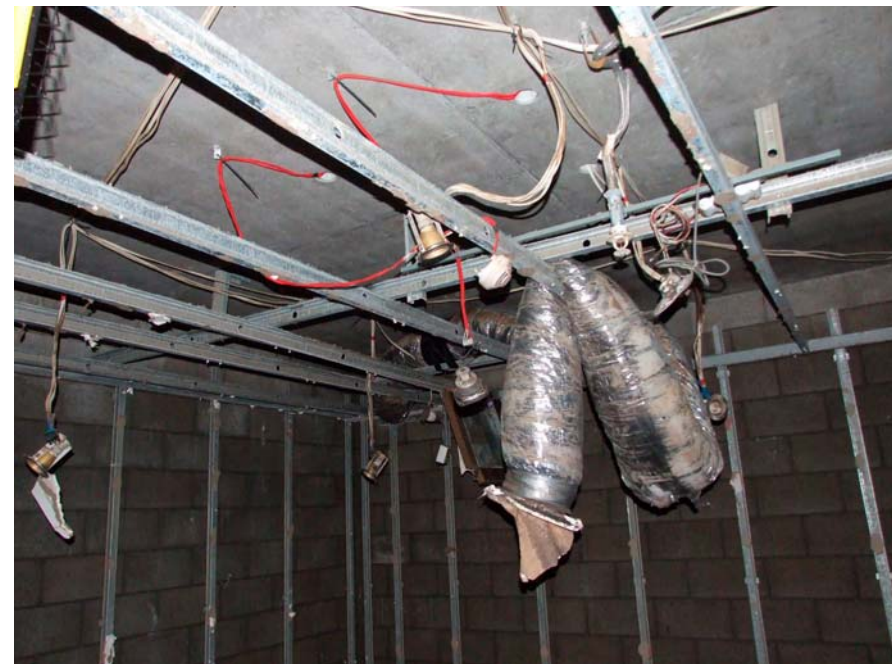
Part of the CO₂ monitoring system

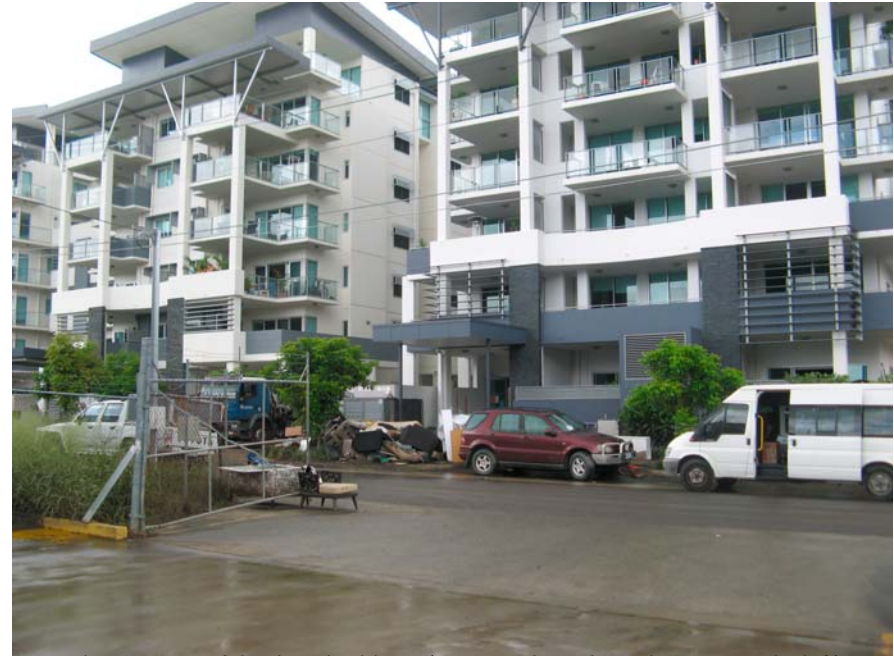
- The Energex transformers for the Aura and Arriva Apartments located in front of Aura's sister building next door sit at the ground floor level, so it was affected by water inundation and had to be turned off when flood waters began rising. That meant that the pumps in the basements stopped working and residents could no longer live in the buildings, even if they were not directly affected by water. The regulations need to stipulate that vital services, such as energy supplies, should be well above any flood levels.

View showing two of the three buildings (Aura on the right and Arriva on the left) serviced by the Energex transformers

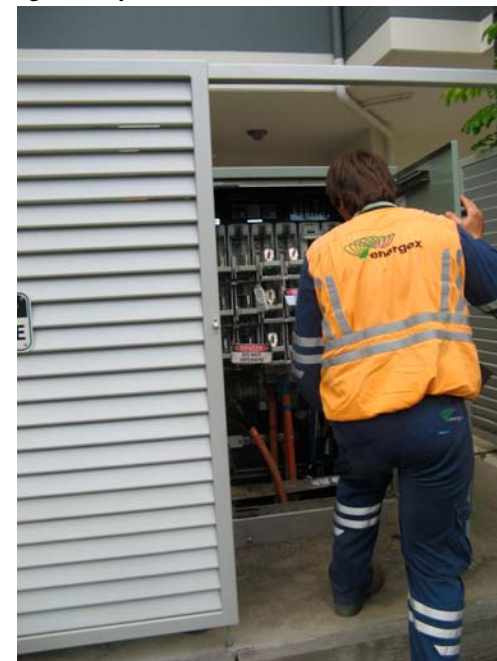
Energex inspecting transformer supplying electricity for Arriva and Aura

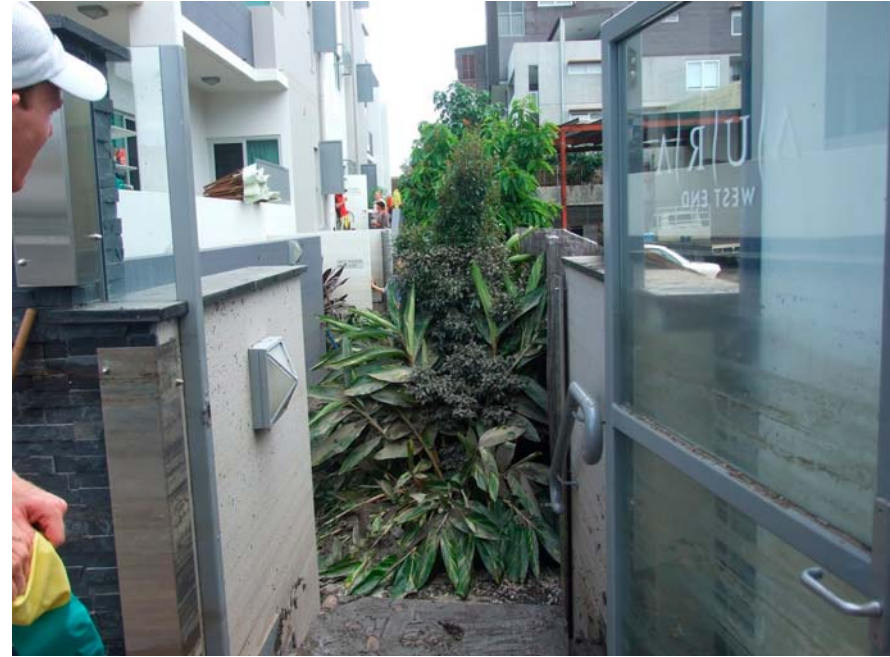
- The gas-fired water heaters and electric pumps were completely submerged and needed to be replaced. Residents did not have hot water for some time and then a limited service until units could be replaced. Located in the sunken garden, these heaters are well below the ground floor level of RL5.9.

Street entrance down some steps at the side of the building leading to the fire stairs halfway along and showing the water heater room (white walls) in the middle

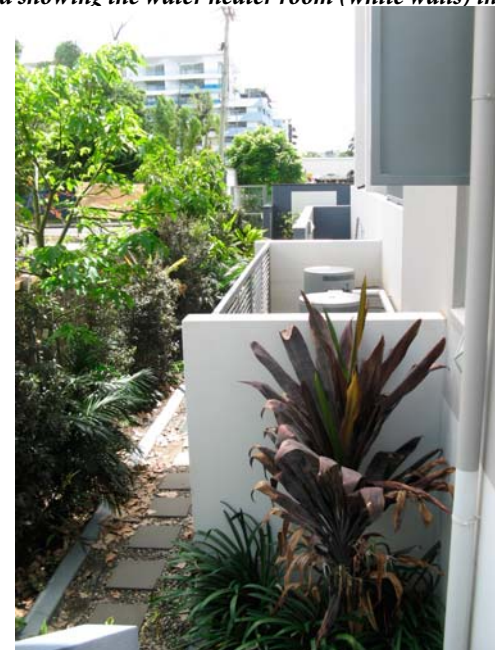
Looking down on the water heaters from the entrance to the fire stairs at ground floor level

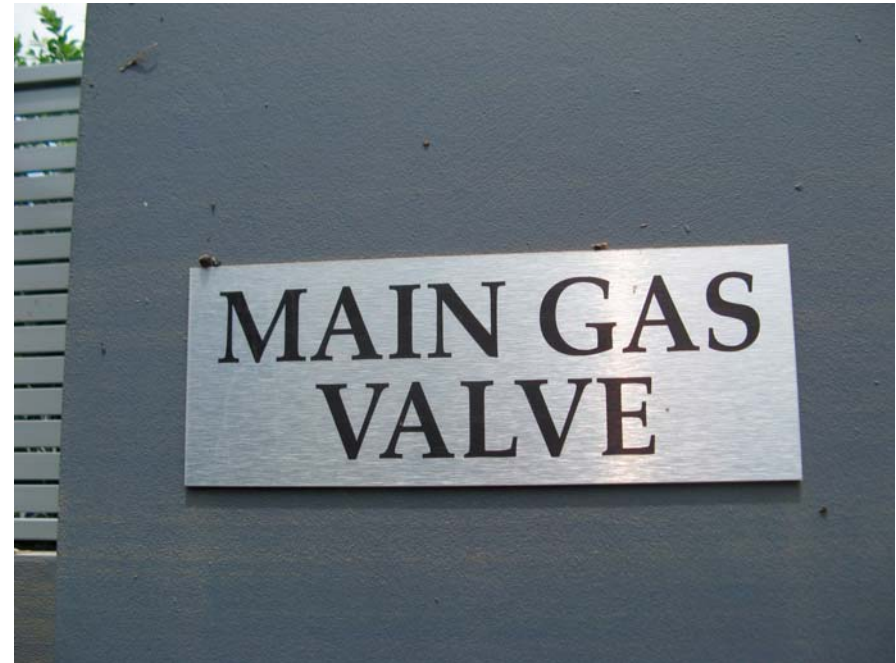
- The gas valves in Aura are located in the sunken garden below ground floor level and were completely submerged by water.

Main gas valve sign beside the stairs to the basements

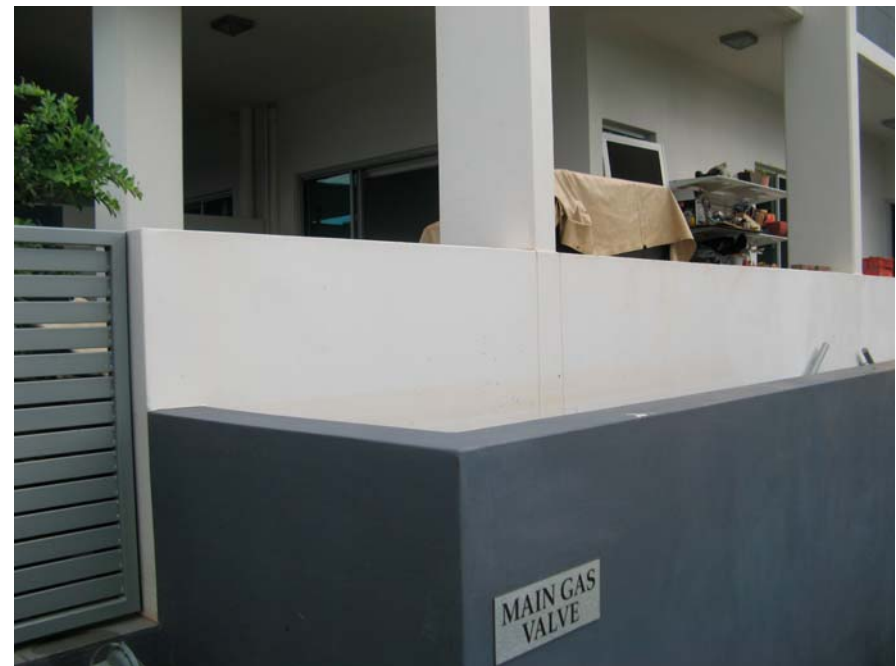
Looking down on the stairs leading to the carpark basements

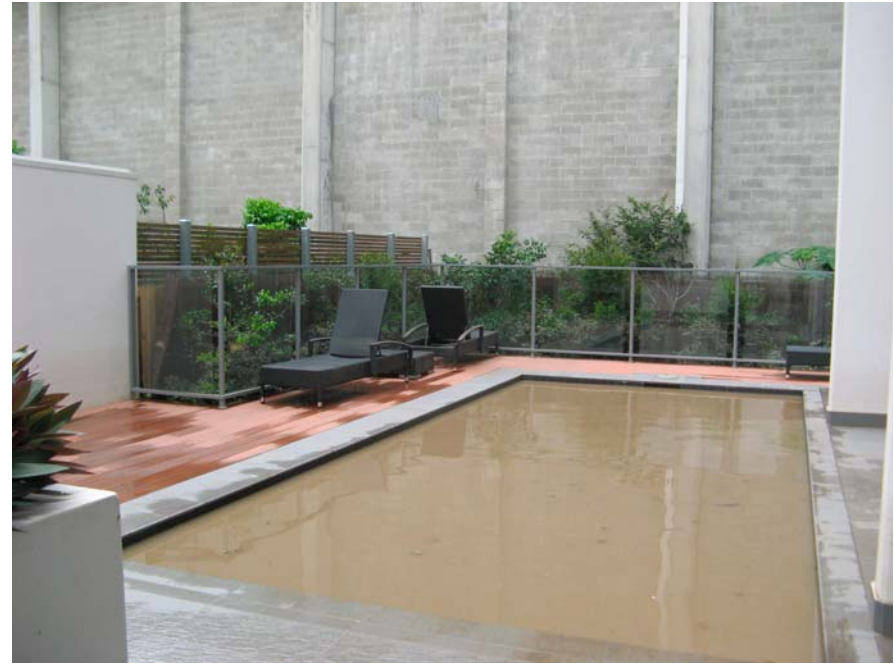
- The Aura pool was inundated by flood waters, but the pool pumps and controls located under the pool in the B1 carpark were also damaged and repairs will cost around \$3000.

Aura pool 14/01/11 at 12.12 pm

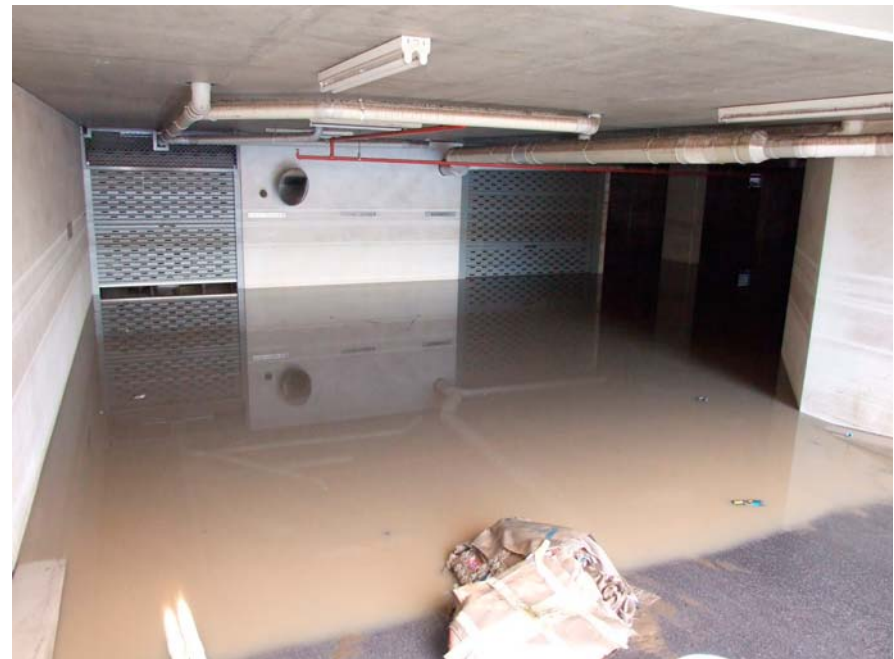
Aura carpark entrance showing room where pool controls are housed in room (left) on Basement 1

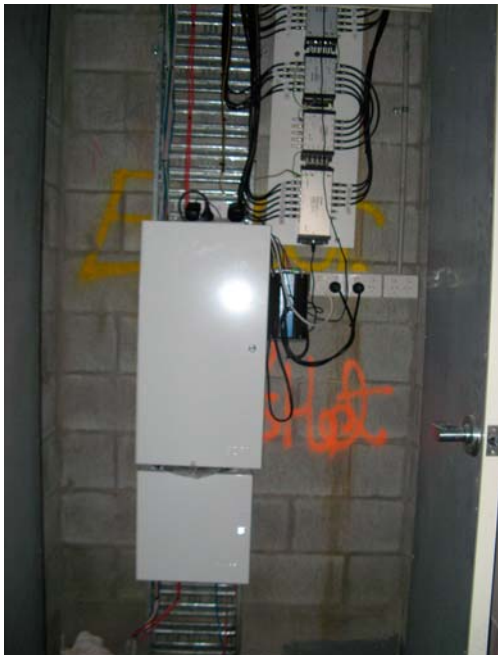
- The power, fire alarm, video and telephone cabling control panels in Aura are on the ground floor so they were partially affected by water, unlike other multi-storey buildings in the West End, which had more major damage because their control panels were located in basements. The Council should require all buildings to have these control panels above any flood levels.

Video cabling controls located on ground floor

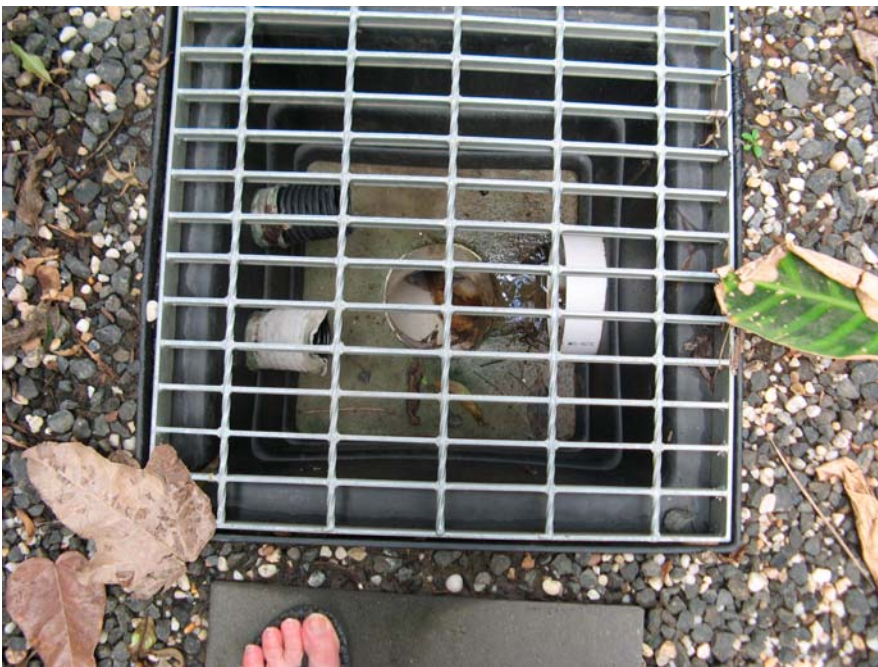
- The stormwater drain around Aura could not cope with the volume of water and the first inundation occurred from stormwater, which bubbled up through the drain with such force it lifted one of the grates. One resident then fell down into the open hole, which was under water. The Council needs to better design for stormwater runoff in West End.
- This stormwater grate is located on the main emergency exit pathway from the fire stairs. The pathway was flooded to knee level at the time the building was evacuated. This is an unsafe design that should not be allowed by the building code.

One of smaller grates giving access to the stormwater drain around Aura

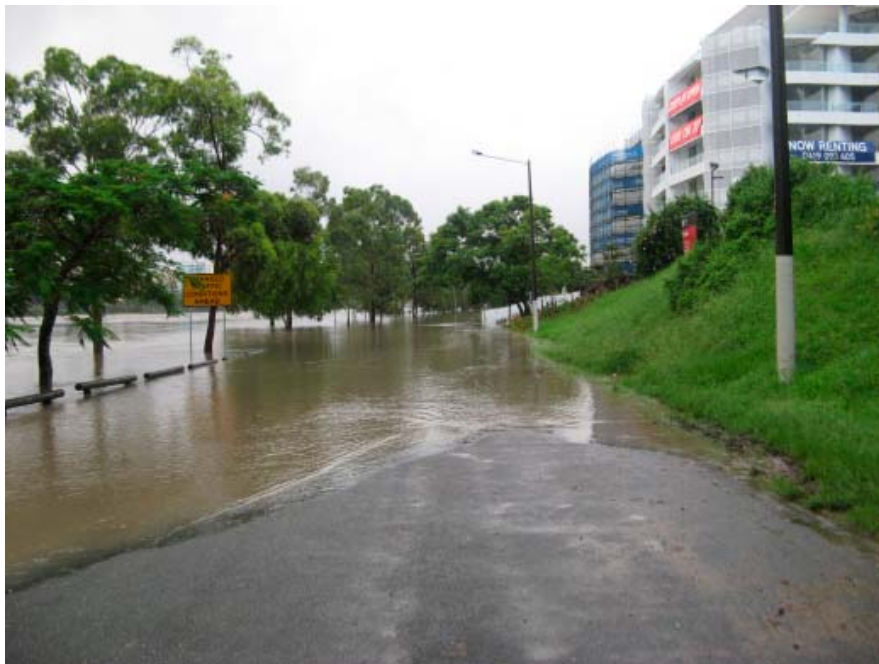
- River water flowed over the bank in places along Riverside Drive and entered buildings and, possibly affected Aura. Instead of requiring developers building beside Riverside Drive to raise the bank, Council allowed the developers of Waters Edge to lower the bank and this was one of the places where river water flowed inland.
- The Council is not fully using substantial funds paid by developers in West End to Council to ensure the main stormwater drainage system is capable of controlling run off.

View of Riverside Drive at 6.33 pm on 11/01/11 showing Waters Edge on the right

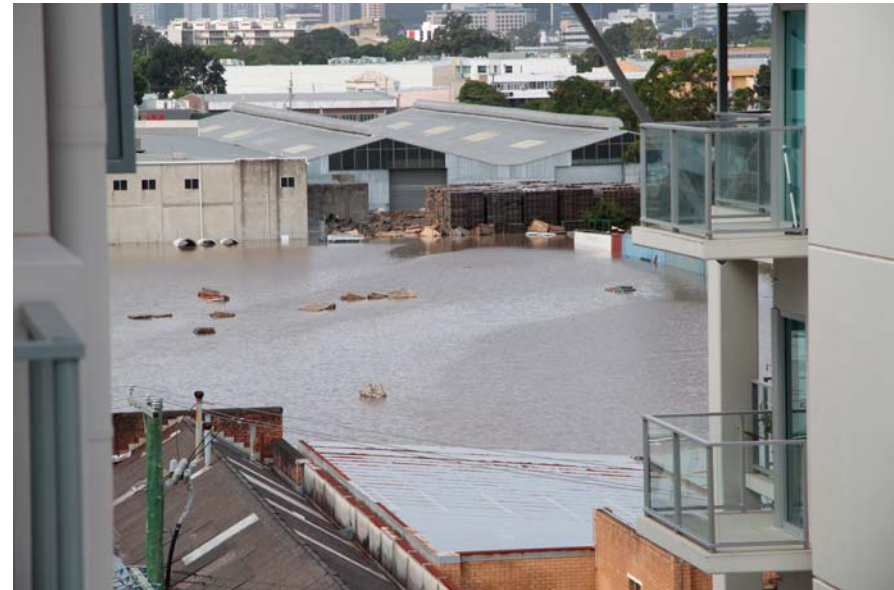
Taken from Unit 32 at Aura on 12/01/11 at 5.13 pm looking towards the city
